## **Arkema Facility - Harvey Response**

Arkema Inc.

September 3, 2017

Project #109489 Summary

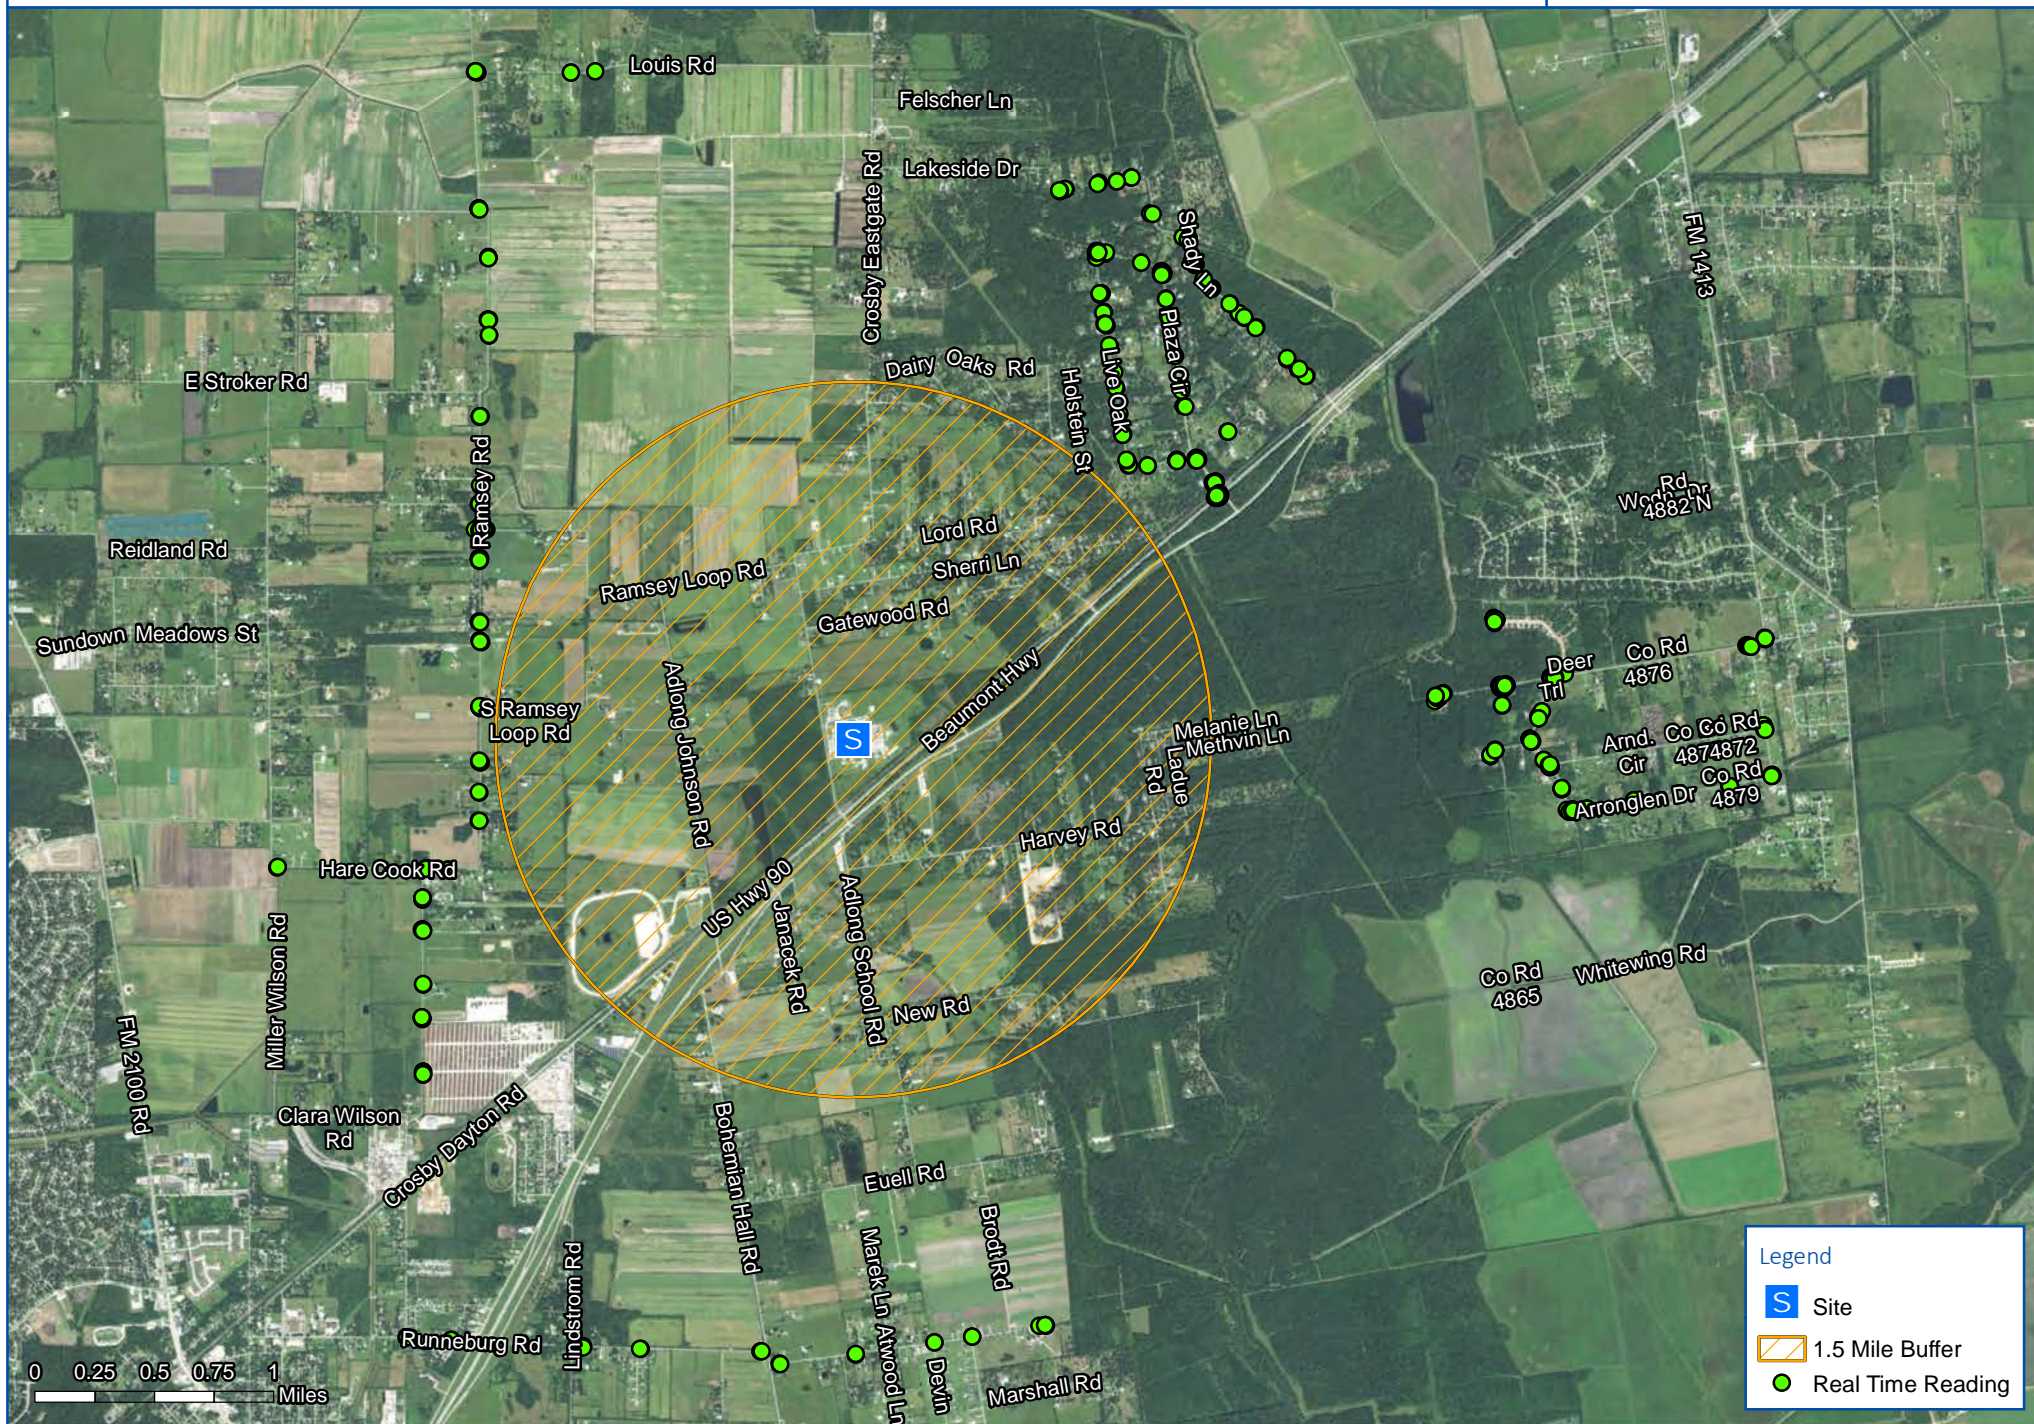
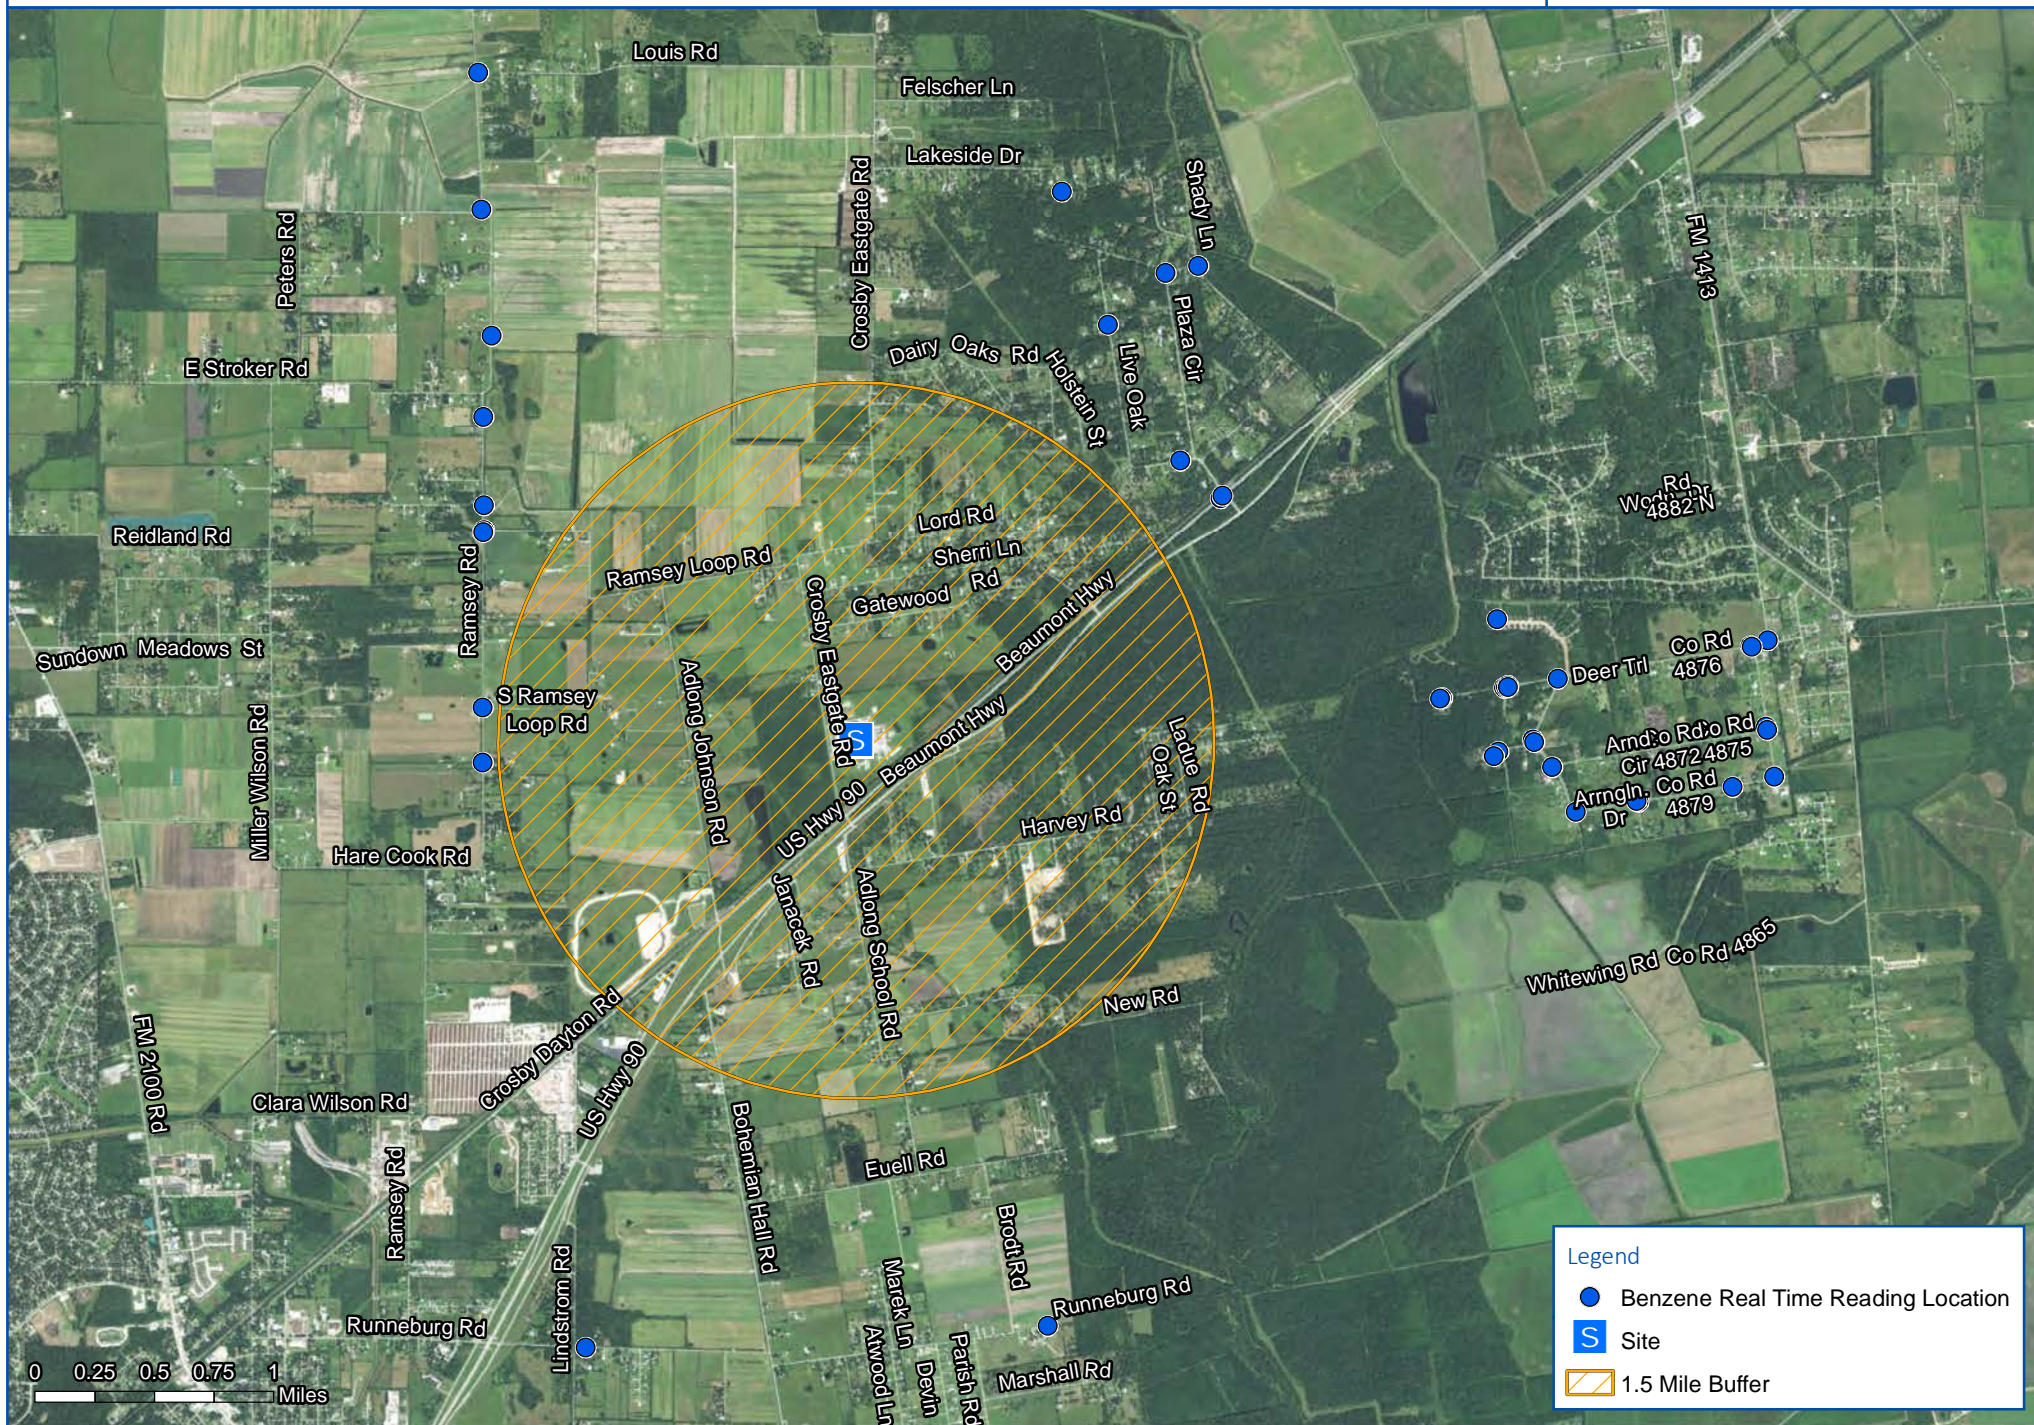
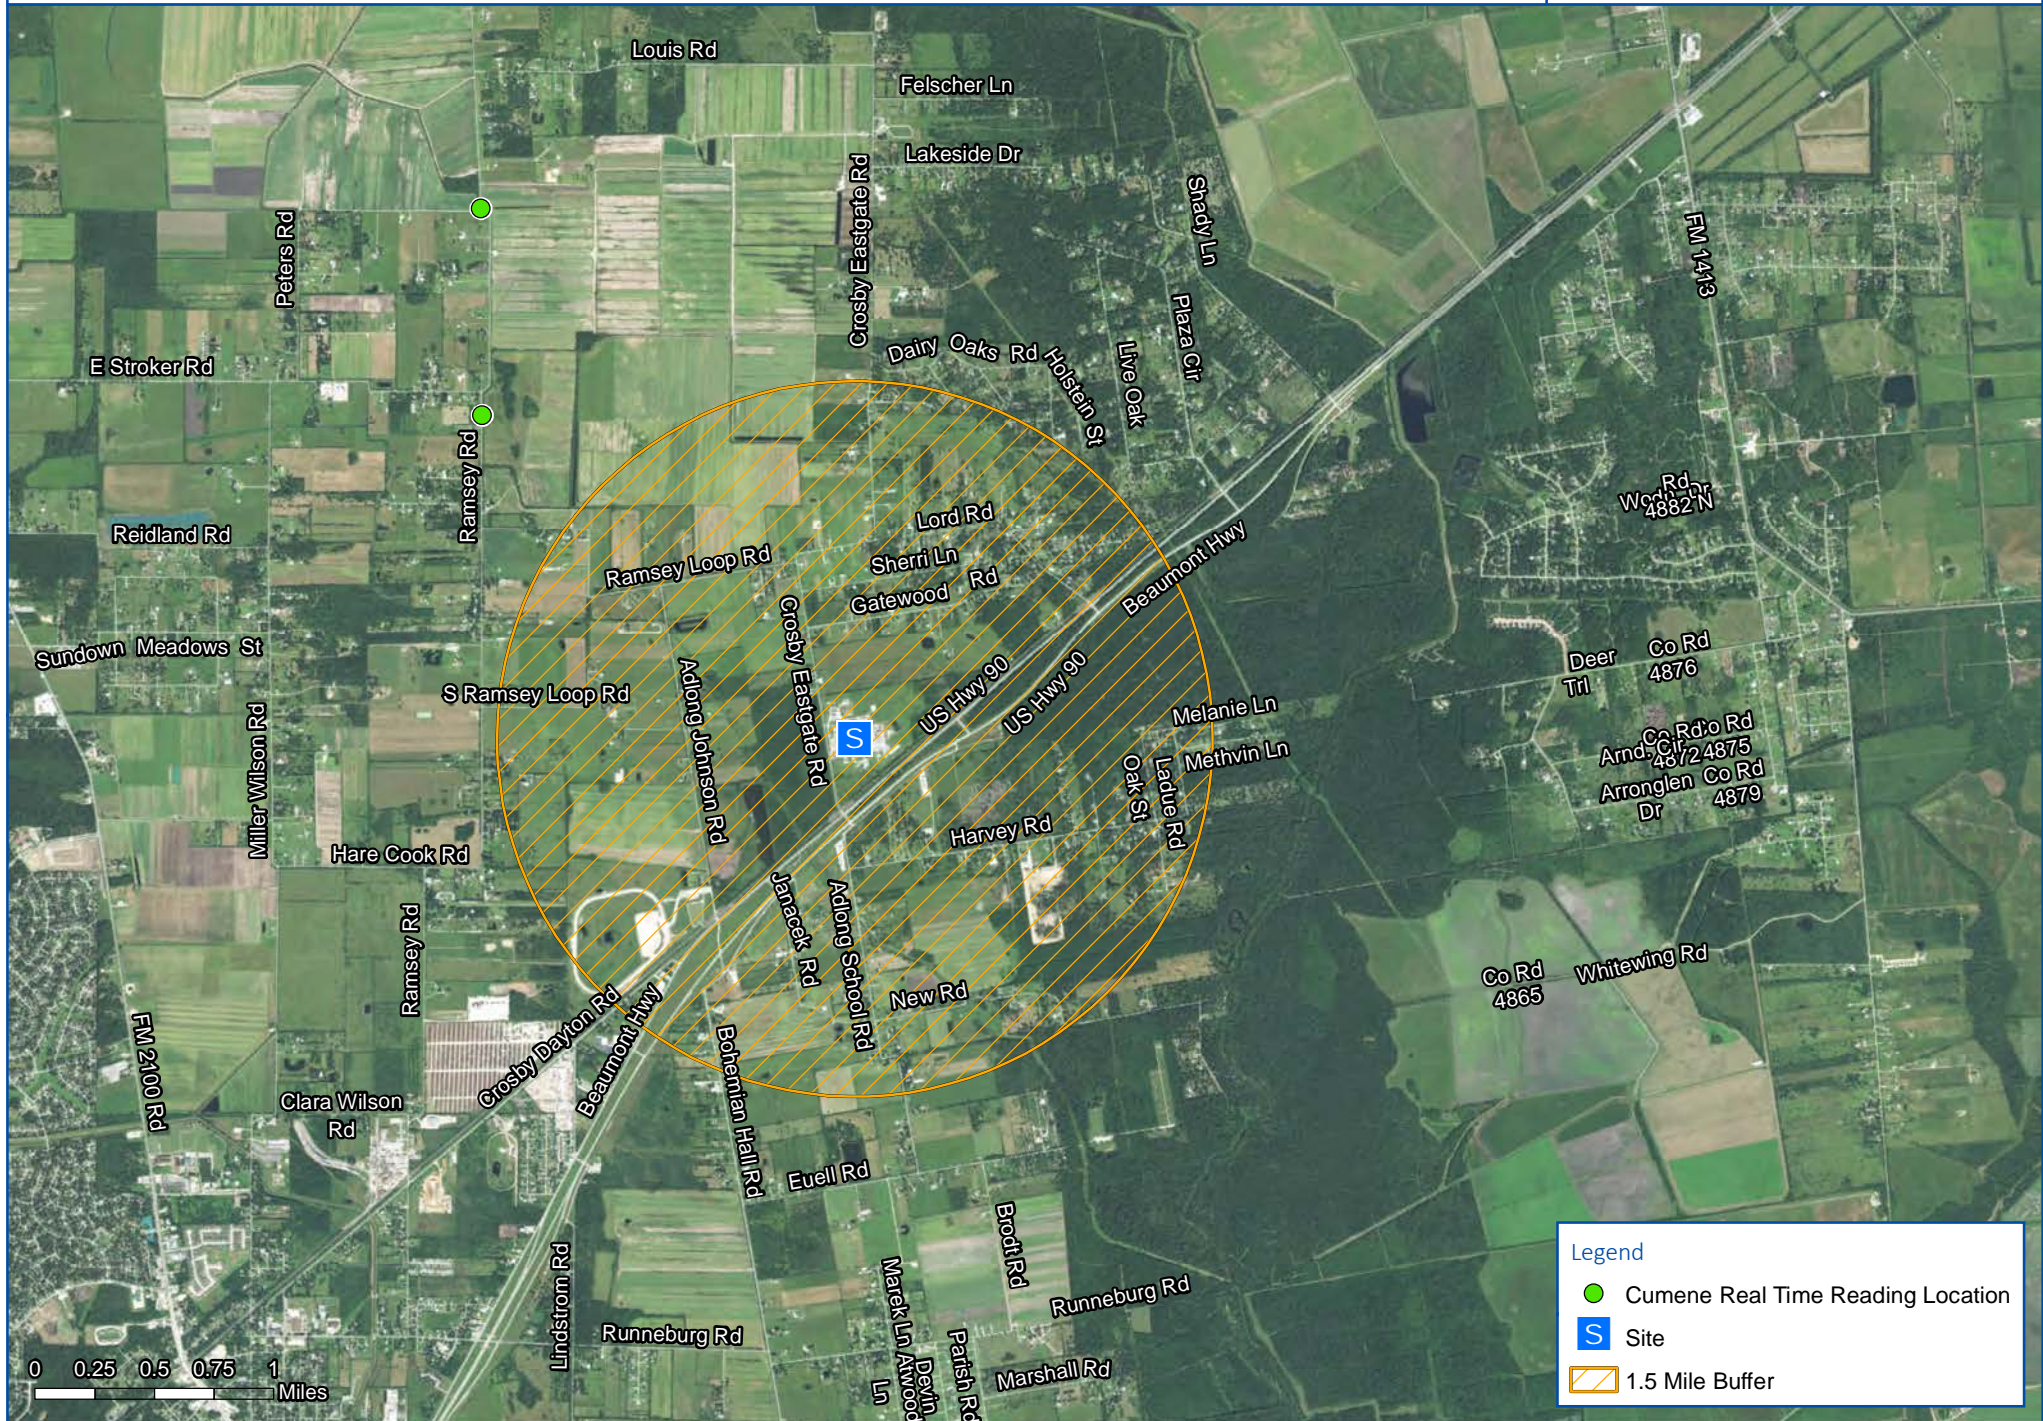
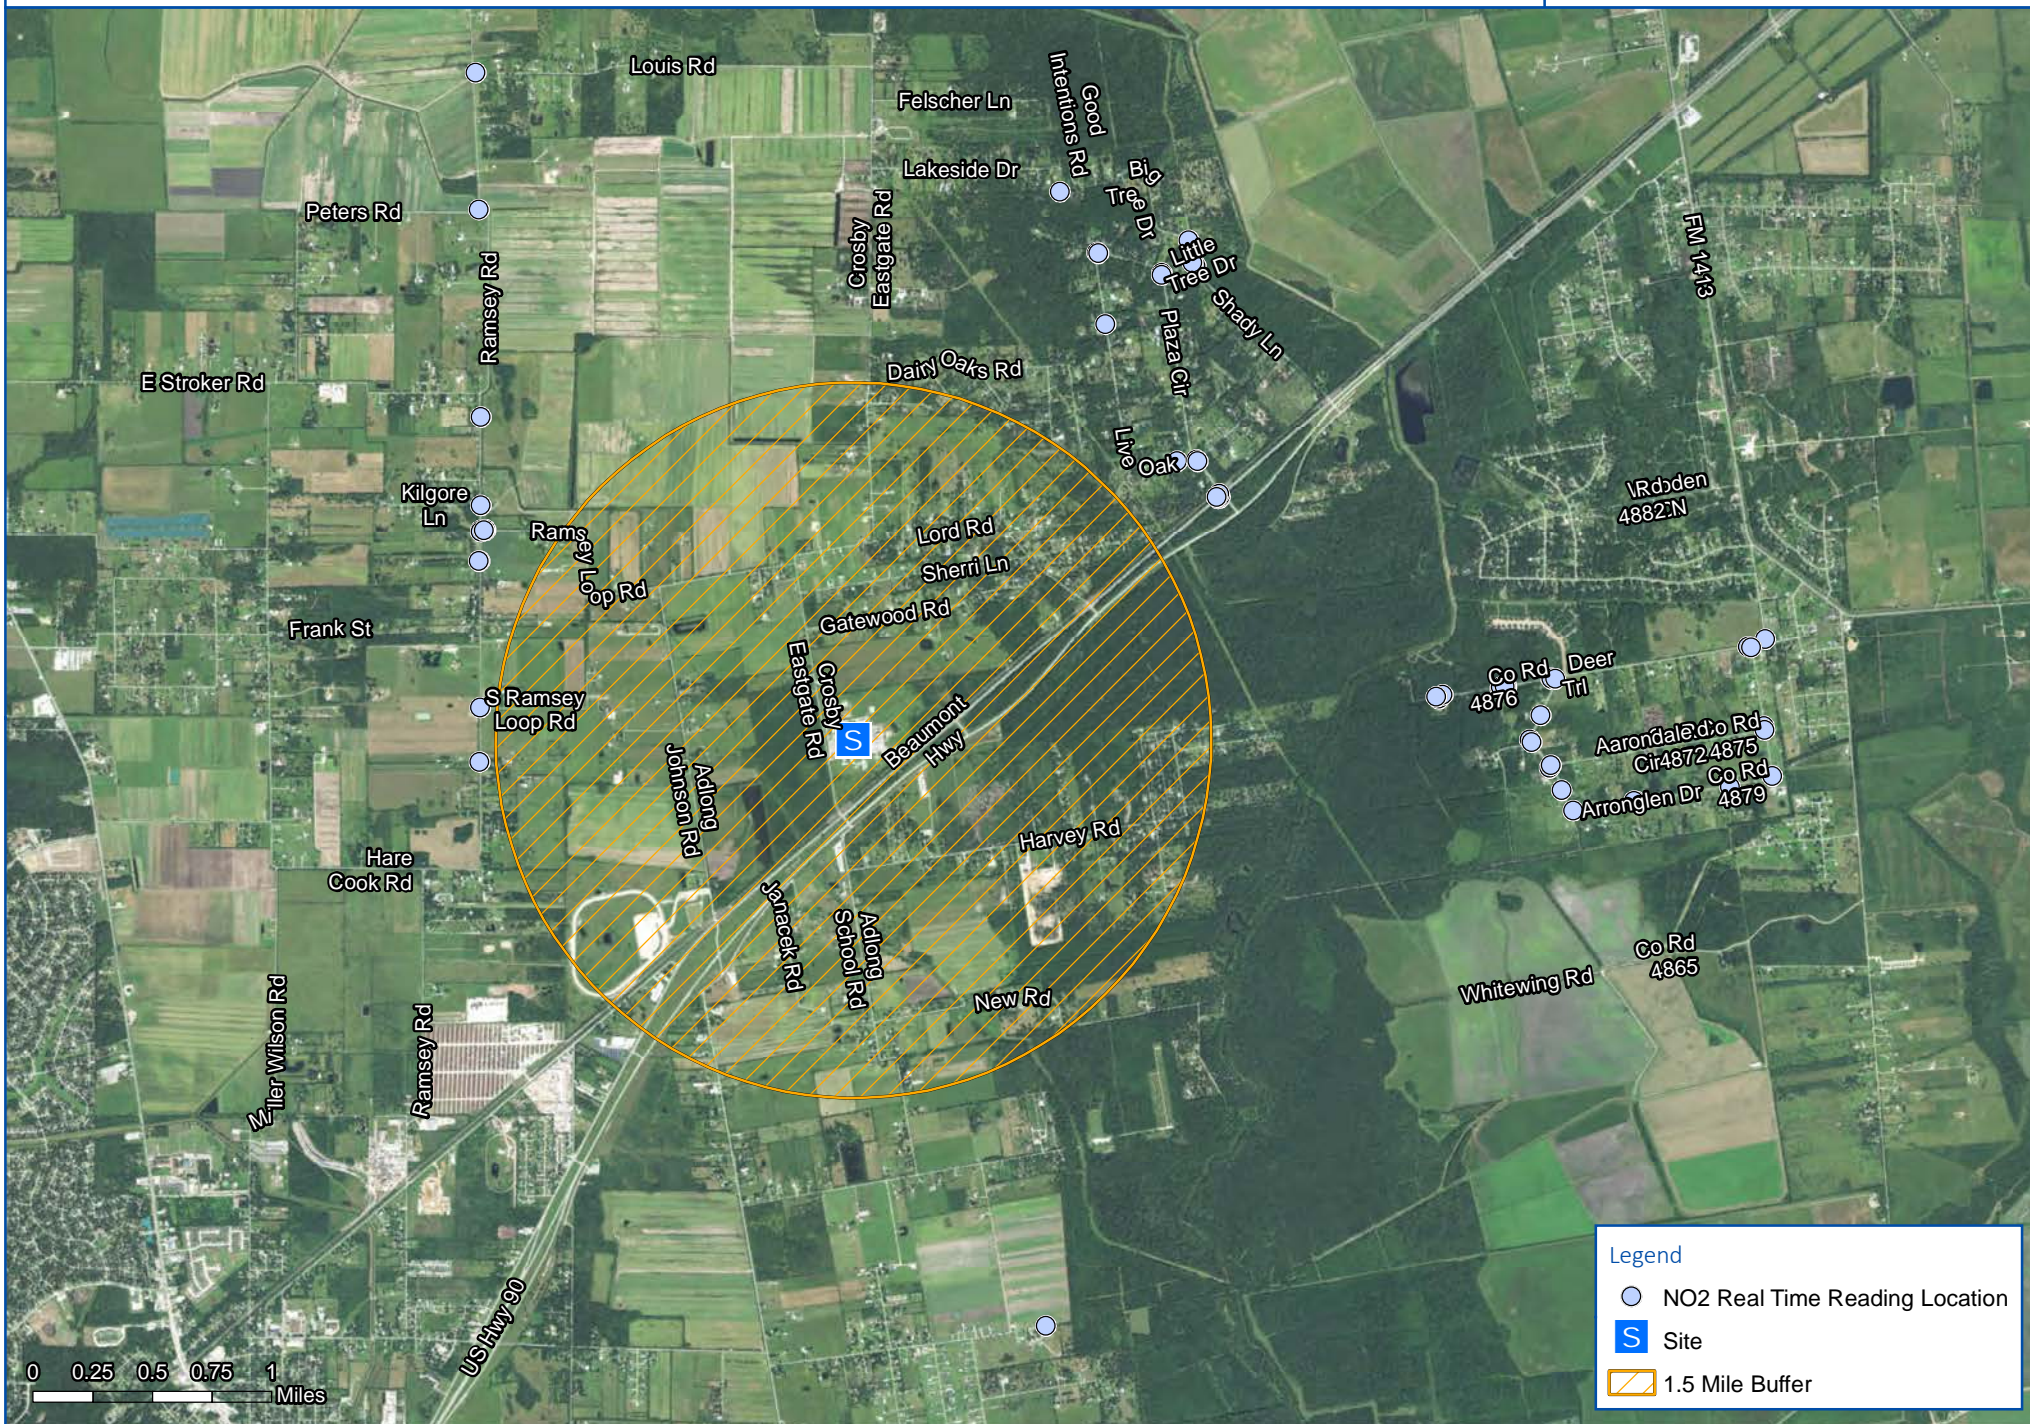
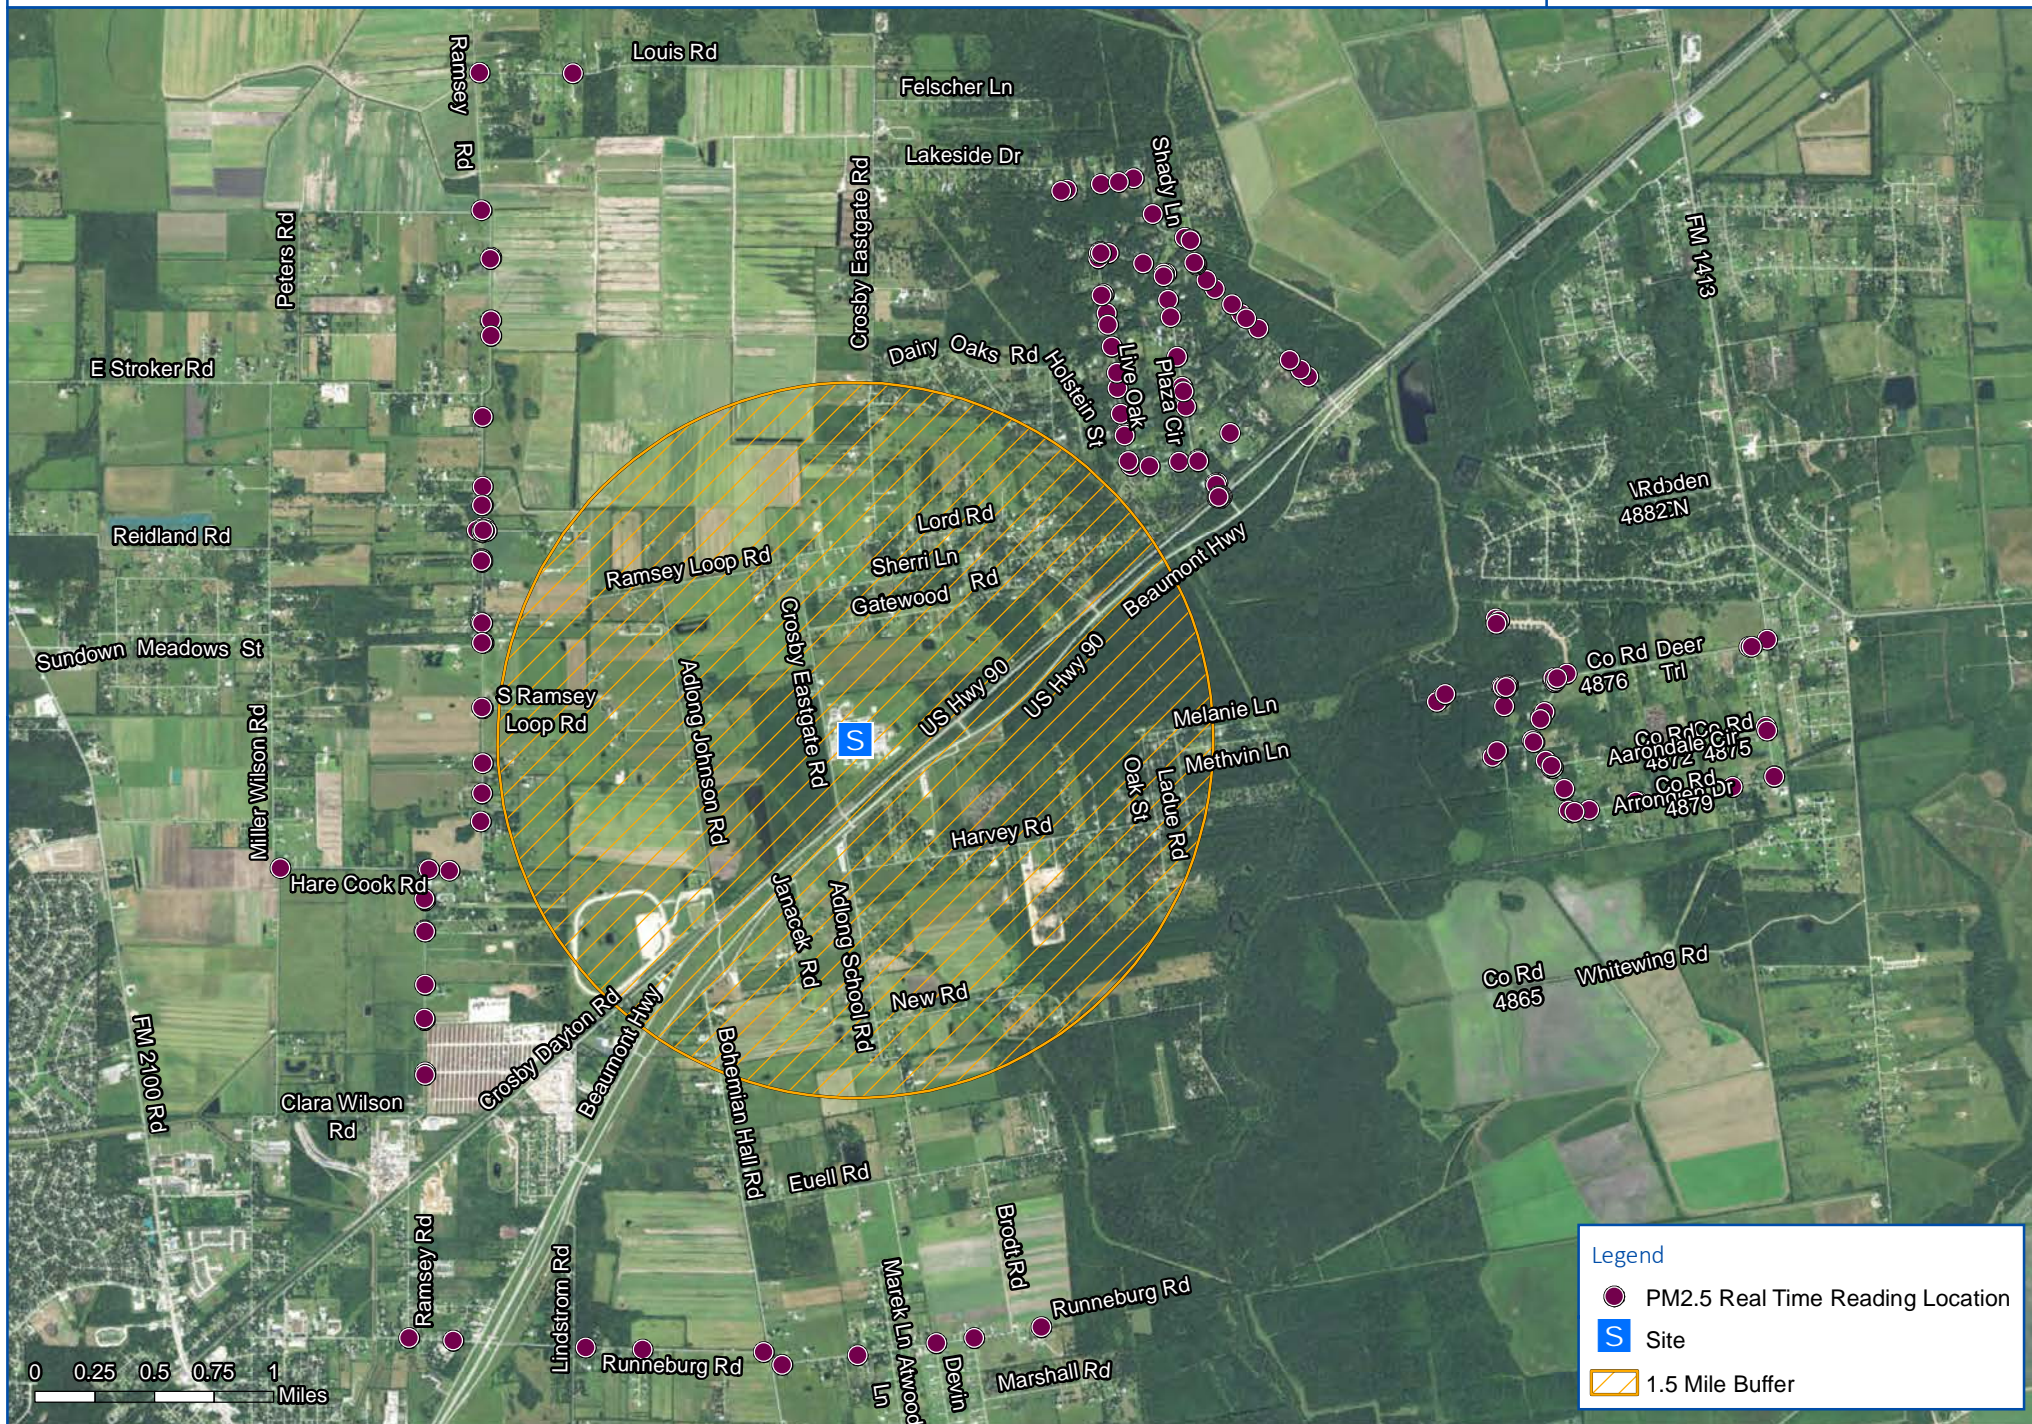
## **Handheld Real-time Air Monitoring Locations**

All real-time air monitoring instrumentation was calibrated per the manufacturer's recommendations prior to air monitoring. Handheld, real-time air monitoring was conducted for benzene, cumene, and volatile organic compounds (VOCs) using RAE Systems and Gastec instruments. Additionally, combustion byproducts potentially associated with fire smoke, such as particulate matter (PM<sub>2.5</sub>), nitrogen dioxide (NO<sub>2</sub>), and sulfur dioxide (SO<sub>2</sub>) were assessed. **Table 1** summarizes the data for all real-time air monitoring readings recorded in Crosby, TX from 06:00 on September 2, 2017 through 06:00 on September 3, 2017. Maps of real-time air monitoring locations are provided as **Attachment B**.

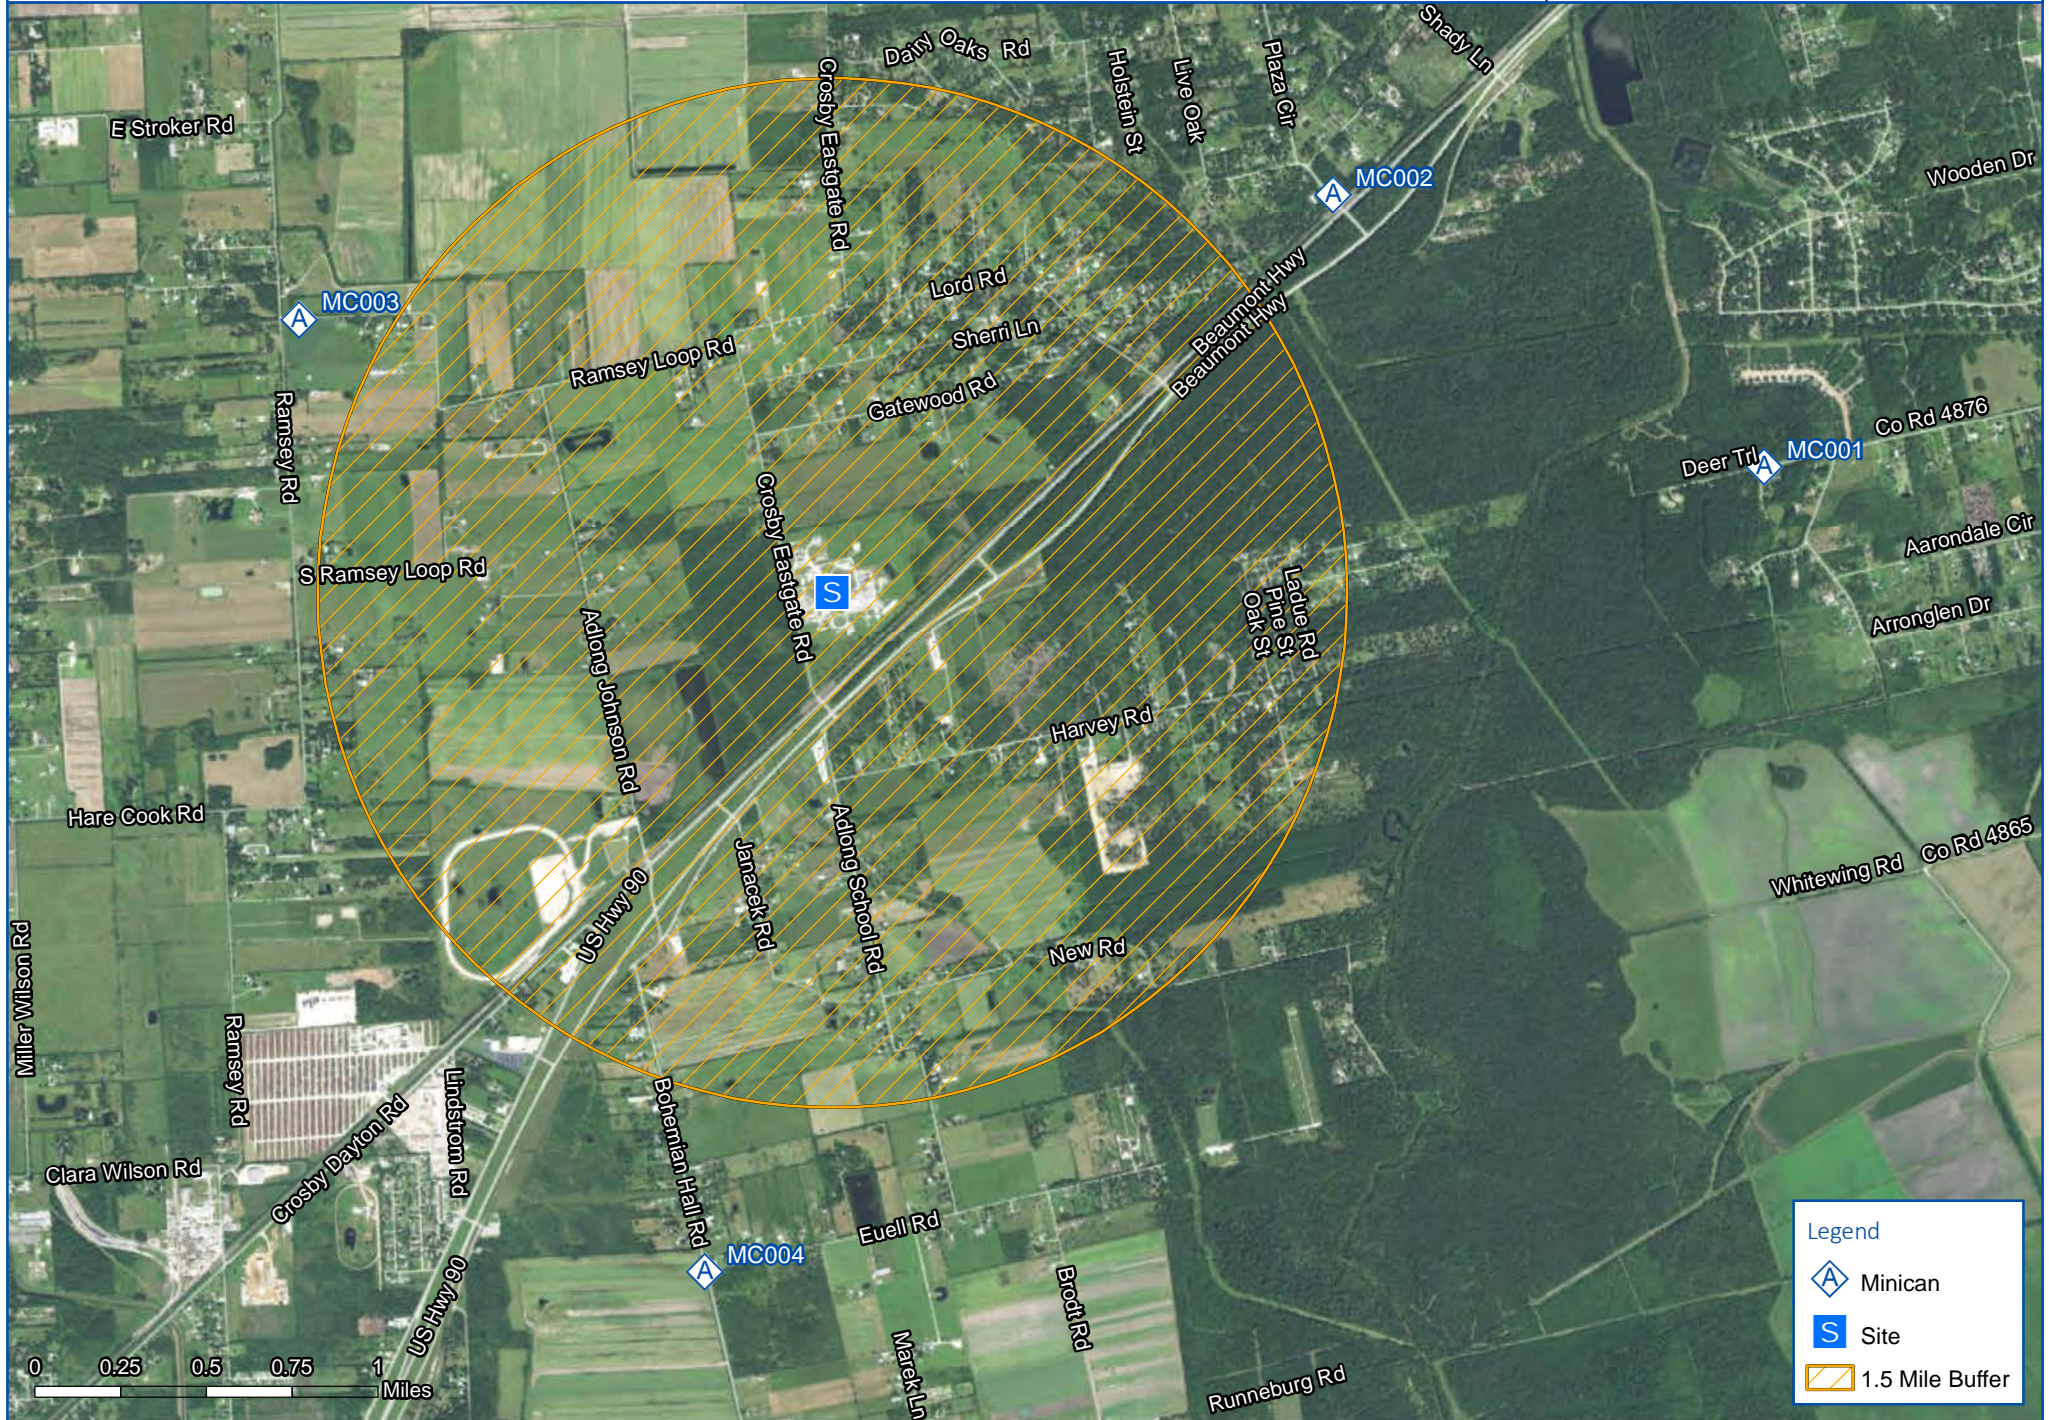
## **Map of Analytical Air Sampling Locations**

To supplement real-time air monitoring, CTEH® deployed areas along the perimeter of the evacuated area within the community. Evacuated canister (Minican™) samplers were regulated to collect air evenly over a 24-hr period. Analytical air samples will be submitted to SGS Galson Laboratories, an AIHA-accredited laboratory, for analysis using EPA Method TO-15. A map highlighting the analytical air sampling locations is provided as **Attachment C**. Analytical Air Sampling Results will be reported upon receipt from the laboratory.

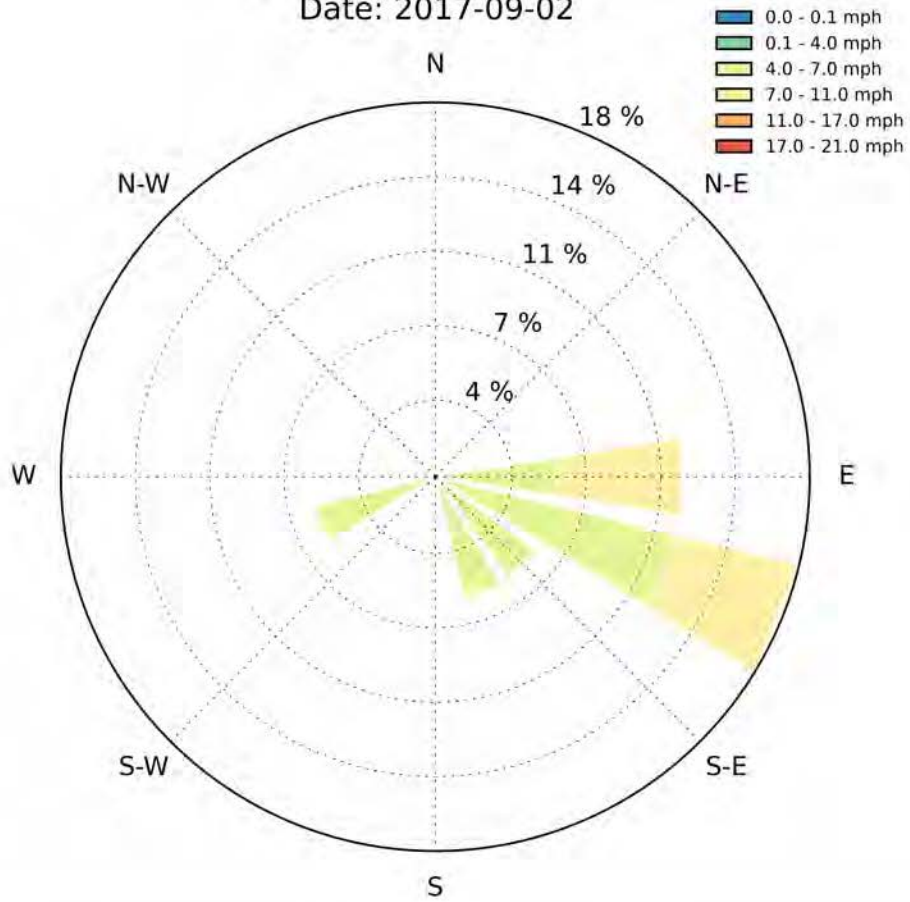
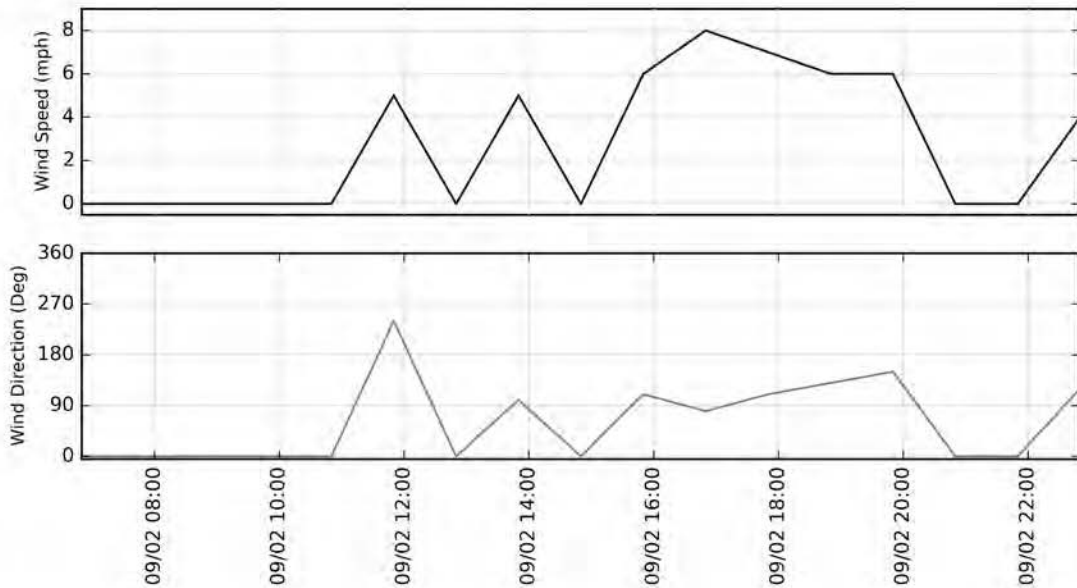
Weather Station: KHPY  
Date: 2017-09-02

## **KHPY Windrose**

**(Highland Park Airport - 12.5 miles SSE of Site)**
